INTRODUCTION

FREQUENTLY ASKED QUESTIONS ABOUT SHIELDING AND FAIL/SAFE COATINGS

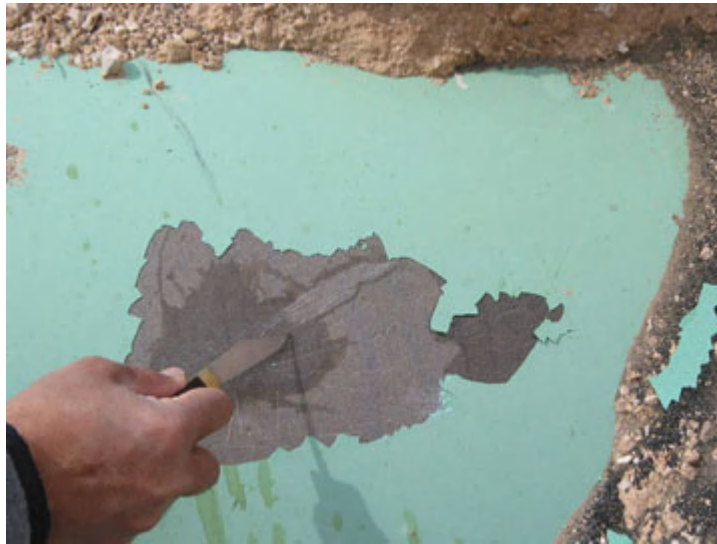
This disbonded FBE had no corrosion underneath. The pH of the water under the blister was elevated (made more alkaline) as the result of the CP currents being able to reach underneath the disbondment.

Therefore FBE may be considered a “fail/safe” coating. If disbondment of FBE occurs (a failure), cathodic protection currents probably will be able to reach the disbonded area.

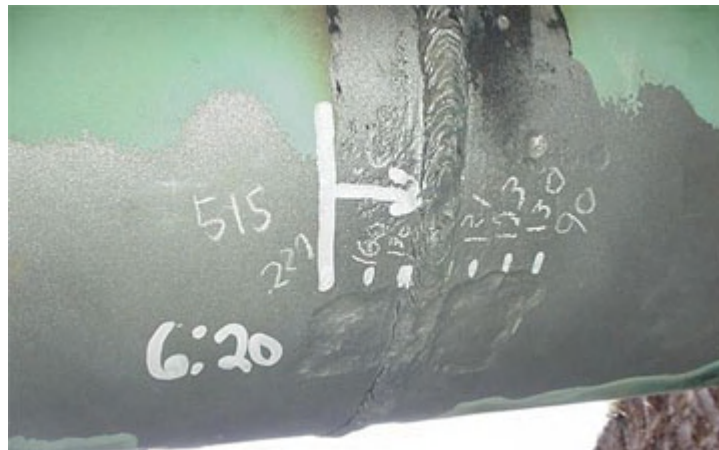
Therefore shrink sleeves should be considered to shield cathodic protection currents. If disbondment of shrink sleeves occurs, cathodic protection currents probably will not be able to reach the disbonded area.

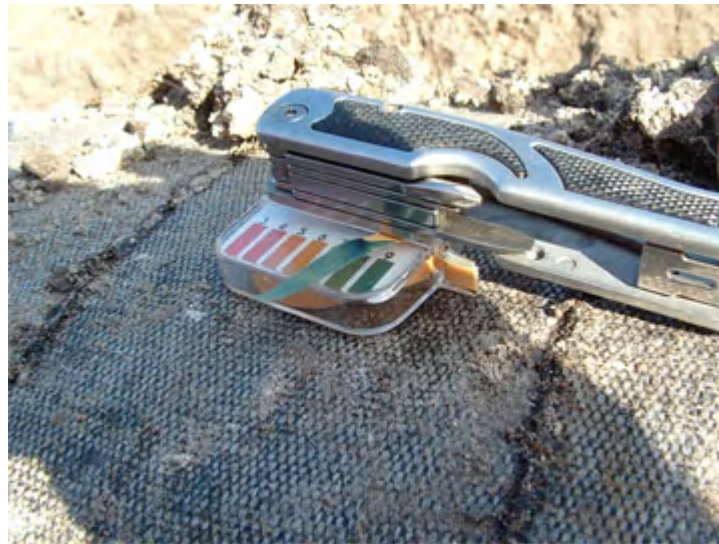
Water underneath a disbonded area of this improperly applied RD-6 had a pH of 9-10, as compared to water under nearby disbonded coal tar coating, which has a pH of 5-6. The CP current had increased the alkalinity of the water under the RD-6 to a level which does not support corrosion.

Therefore RD-6 may be considered a non-shielding coating. If disbondment of RD-6 occurs - cathodic protection currents probably will be able to reach the disbonded area.
